TEST OF A FLAT SLAB FLOOR
OF THE
WESTERN NEWSPAPER UNION
BUILDING

BULLETIN No. 106

ENGINEERING EXPERIMENT STATION

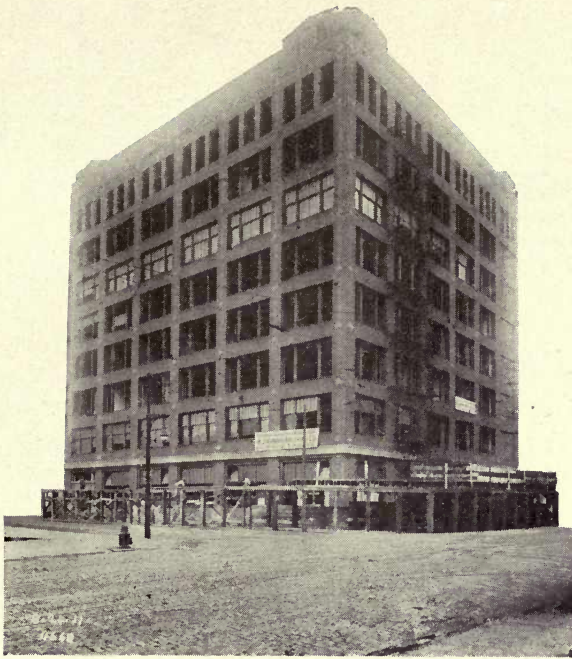
FIG. 1. VIEW OF WESTERN NEWSPAPER UNION BUILDING AT TIME OF TEST

3. *The Building.*—The Western Newspaper Union Building was an eight-story reinforced concrete structure located at Clinton and Adams Streets, Chicago. The building was erected in the spring of 1909 by the George Hinchcliff Company, contractors, according to plans furnished by S. N. Crowen, architect, and Ritter and Mott, engineers. It had been in use by a printing company until 1916. The floor tested had been occupied by printing presses. Fig. 1 is a view of the building at the time of the test; the wrecking of the building had begun.

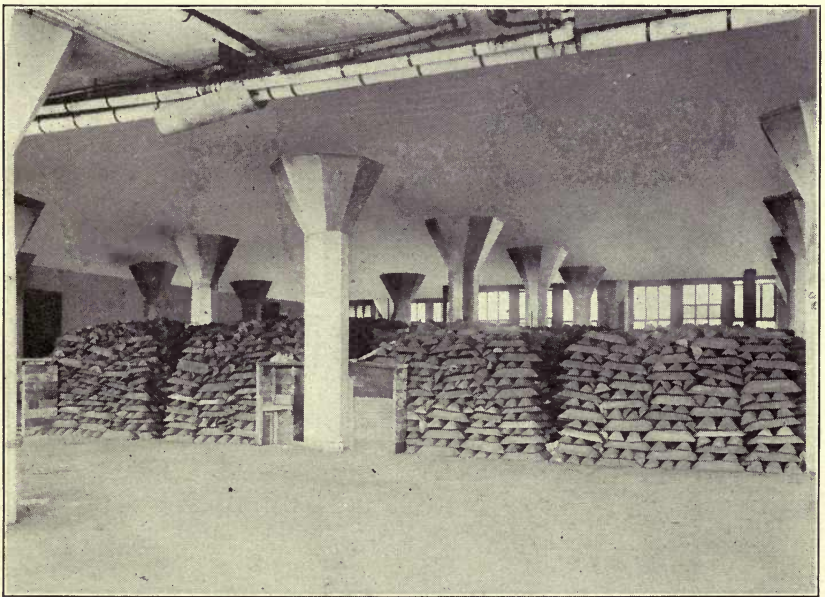
FIG. 2. VIEW SHOWING FULL LOAD ON FLOOR

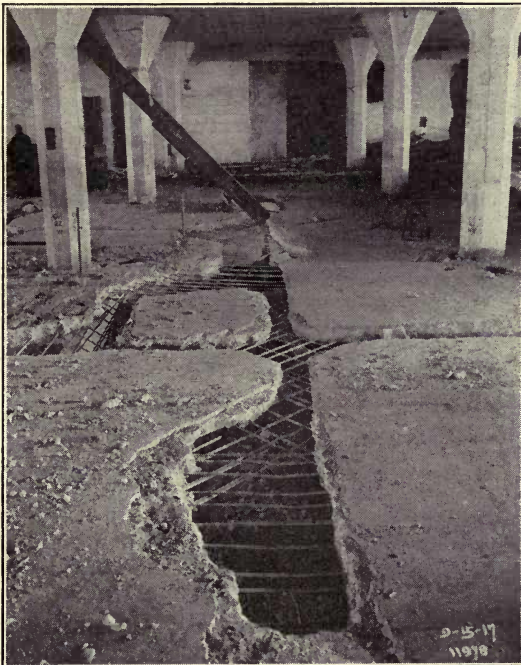
FIG. 21. VIEW OF SLAB AFTER REINFORCING BARS WERE EXPOSED

17. *Wrecking of the Floor.*—As soon as the load was removed, portions of the floor in the four panels of the loaded area were broken into to uncover the reinforcing bars at important sections. Measurements of the position and location of the reinforcing bars were made for use in calculation. The thickness of the floor was measured at a number of points to check the values obtained from level readings. Photographs were taken to give a record of the position and location of reinforcing bars and their laps; Fig. 21 is a sample. As the wrecking of the floor by the contractor progressed, further measurements of the position of the reinforcing bars and their laps, including those in the bands outside of the loaded area, were taken.
